**2005
PROJECT
STRUCTURE REPORT**

**INSPECTION OF
FLOOD CONTROL STRUCTURES ON THE
SACRAMENTO AND SAN JOAQUIN RIVERS
AND THEIR TRIBUTARIES**

**Prepared By
The Flood Operations Branch**

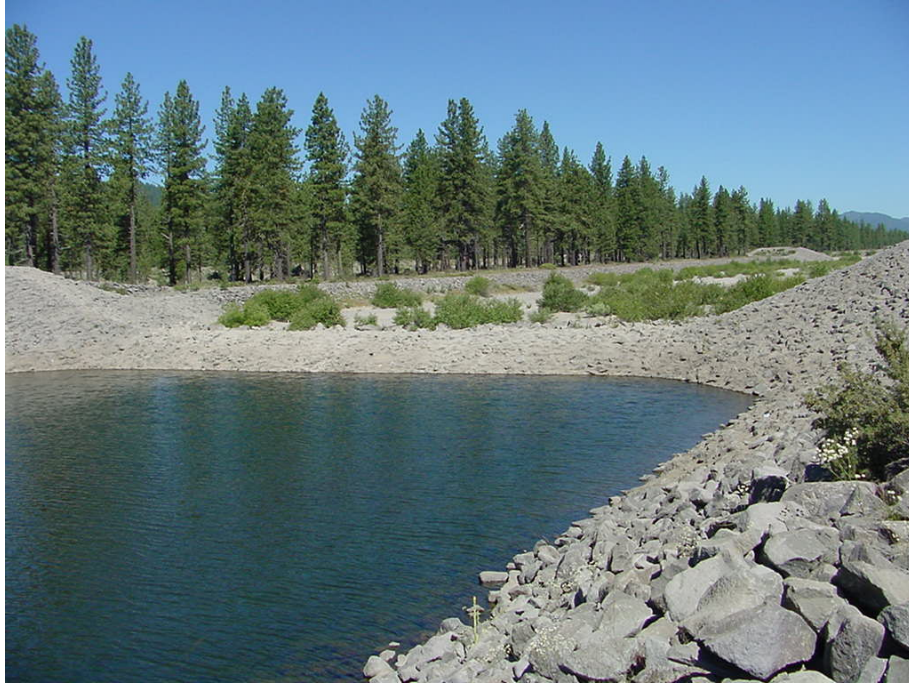
**View of Drop Structure No. 1 from the left bank.
Typical of all drop structures.**

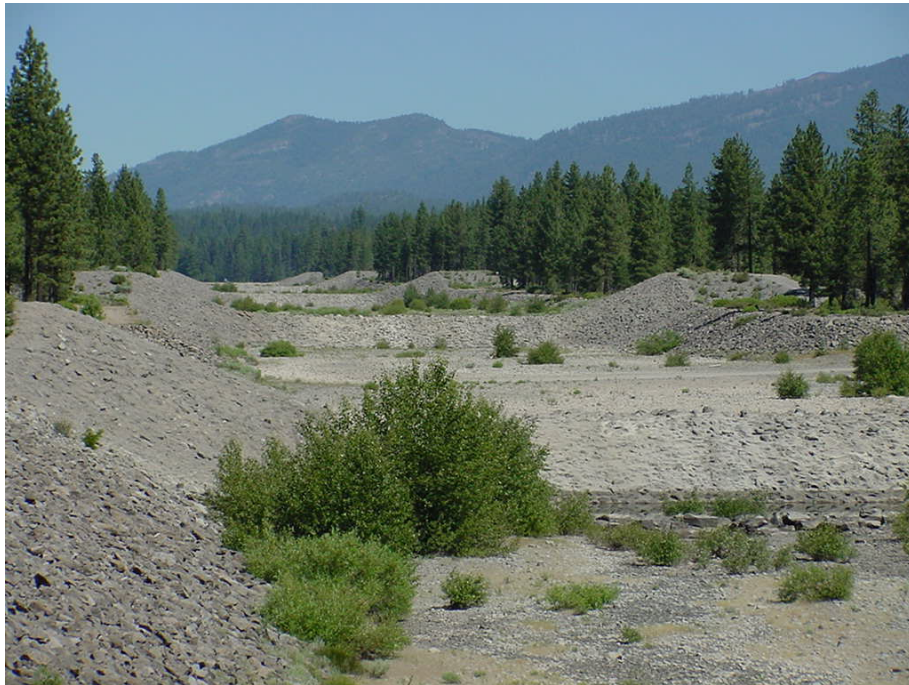
**Looking north from the Hwy 36 bridge at drop
structures 3 through 7, note vegetation in the channel.**

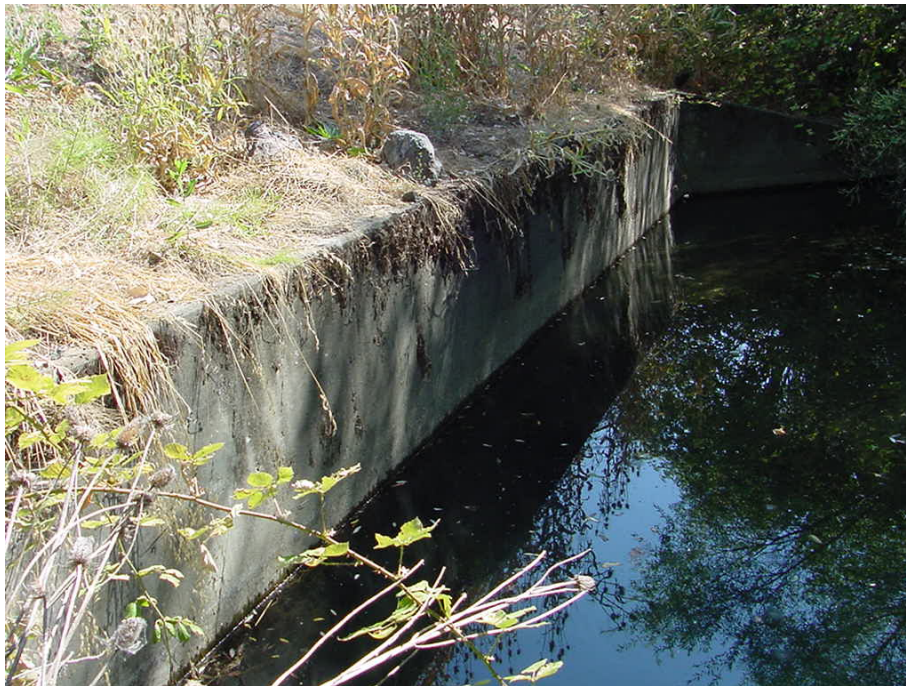
**View of the structure outlet.
Gravel buildup has reduced flow.**

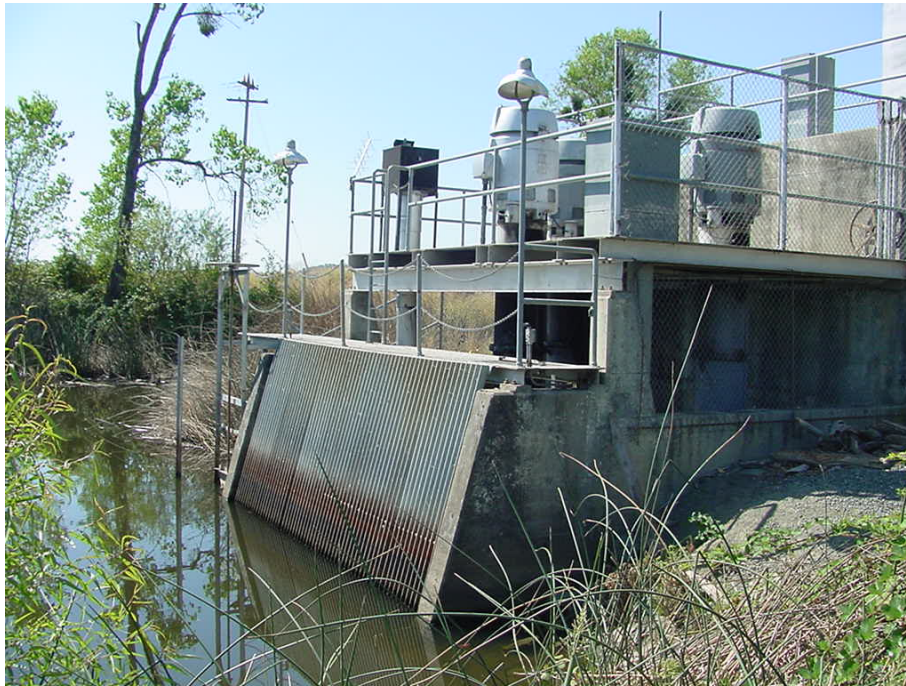
1. **Condition of main pump structure and switchboard house.**
 - a. **Poor. The separation between the top of the surge box and the structure appears to have an eight and one half inch side displacement. The surge chamber has settled twelve inches since 1962 and is 7.6 feet below the top of the structure. There is approximately a two inch deflection. There have been no changes since last reported.**

View of the pumping plant, sump and trash racks.

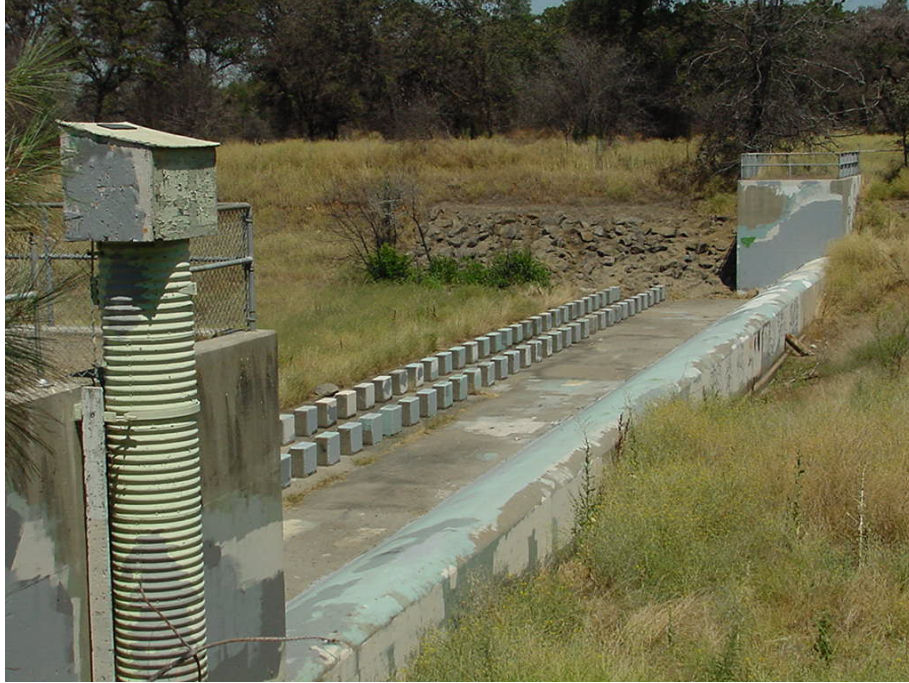
1. **Condition of concrete weir structure and stilling basin, and velocity dissipaters.**
 - a. **There are minor joint separations on the north and south ends of the weir where it contacts the abutments. The separations appear to be stable.**
2. **Condition of concrete abutments and wing walls.**
 - a. **Good.**
3. **Condition of revetment.**
 - a. **Good.**
4. **Accumulation of trash and debris around the structure or in the channel.**
 - a. **None.**
5. **Vegetation around structure or in the channel.**
 - a. **None.**
6. **Condition of gauging house and equipment.**
 - a. **Poor. The gauging house is non-functional.**
7. **Comments:**
 - a. **Repair or replace the gauging house.**
 - b. **Fair maintenance.**

Upstream side of the structure from the left bank.

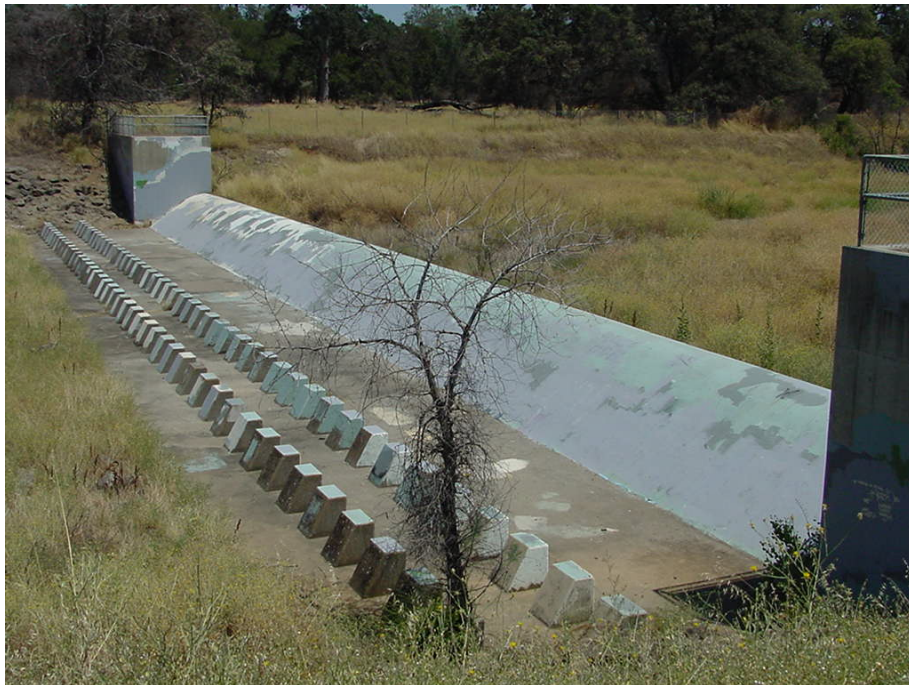
The velocity dissipaters on the downstream side of structure from the left bank.

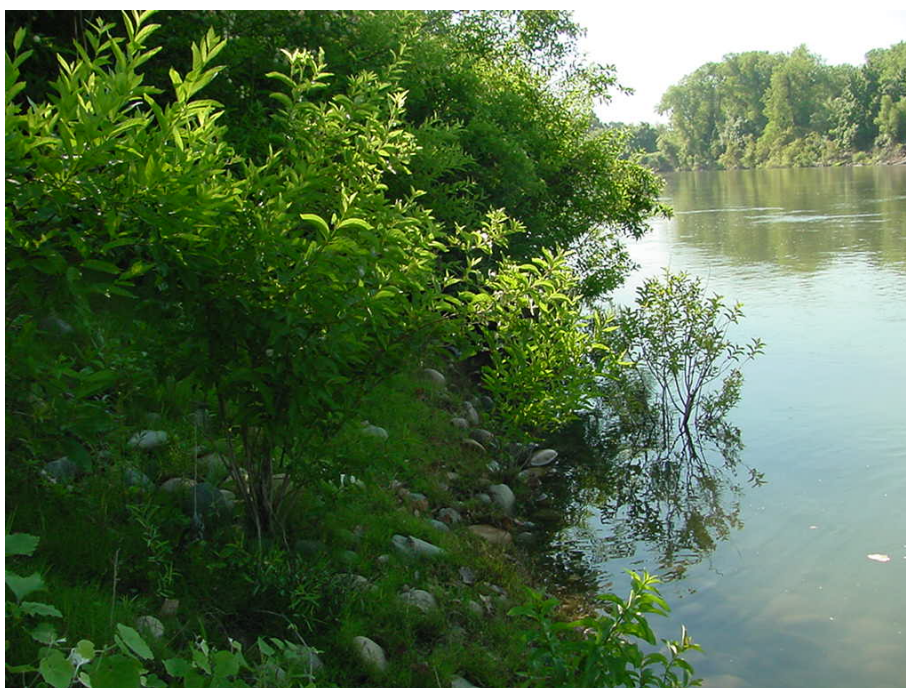
- 1. Condition of the corrugated metal pipe (CMP) drainage structure.**
 - a. Good.**
- 2. Condition of the control gate, mechanisms, and flap gates.**
 - a. Good**
- 3. Condition of the revetment.**
 - a. Good.**
- 4. Accumulation of trash and debris around the inlet, in the pipe or in the channel.**
 - a. Minimal.**
- 5. Vegetation around the structure or in the channel.**
 - a. The vegetation immediately around the in-take has been cleared. Growth is so dense that discharge end of structure cannot be seen.**
- 6. Comments:**
 - a. Remove vegetation from discharge end of structure. If growth is not removed, the drainage structure could become non-functional.**
 - b. Fair maintenance.**

**View of the dense vegetation at the outlet.
Outlet pipes are not visible.**

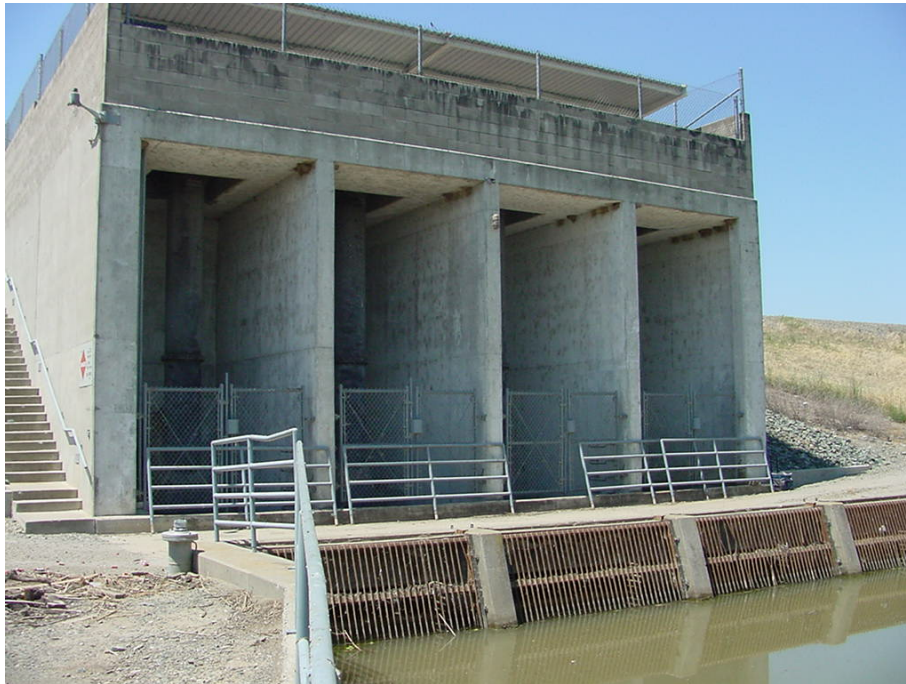
**The intake side of the pumping plant.
Note: Safety railing should be reinstalled.**

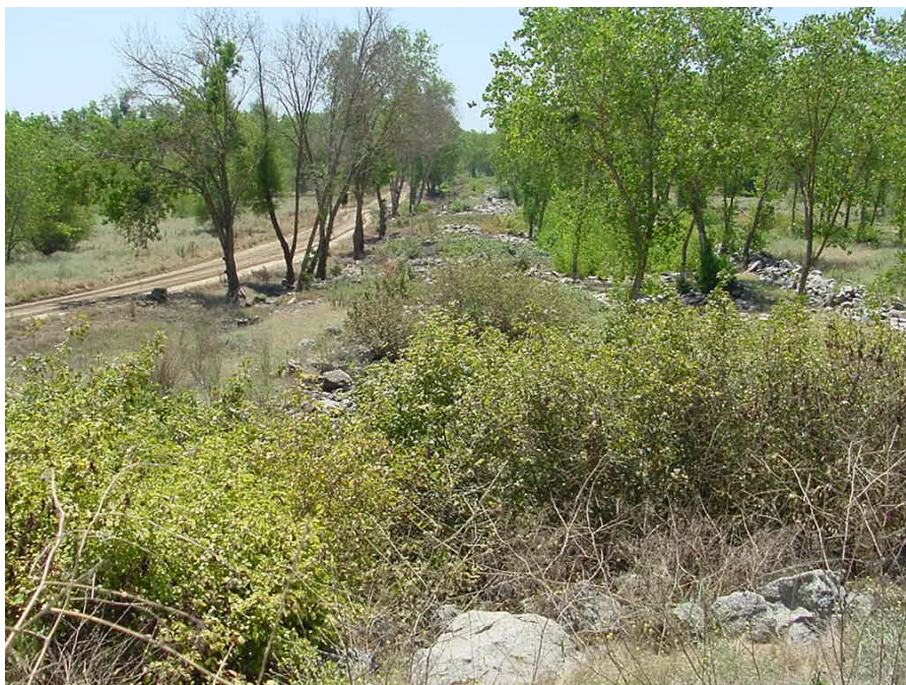
- 1. Condition of quarry rock weir section.**
 - a. Good.**
- 2. Condition of revetments.**
 - a. Good.**
- 3. Accumulation of trash and debris around structure or in the channel.**
 - a. Areas of debris exist along the weir and in the channel.**
- 4. Vegetation around structure or in the channel.**
 - a. Vegetation is very heavy, with trees, brush and berries on the weir section and in the rock revetments.**
- 5. Comments:**
 - a. No clearing done since 1985. The vegetation is extremely dense and could impair the functioning of the weir.**
 - b. Poor maintenance.**
 - c. An unauthorized barricade has been installed at each end of Nelson Bend Rock Quarry Weir.**

View of the weir from the north/east end.

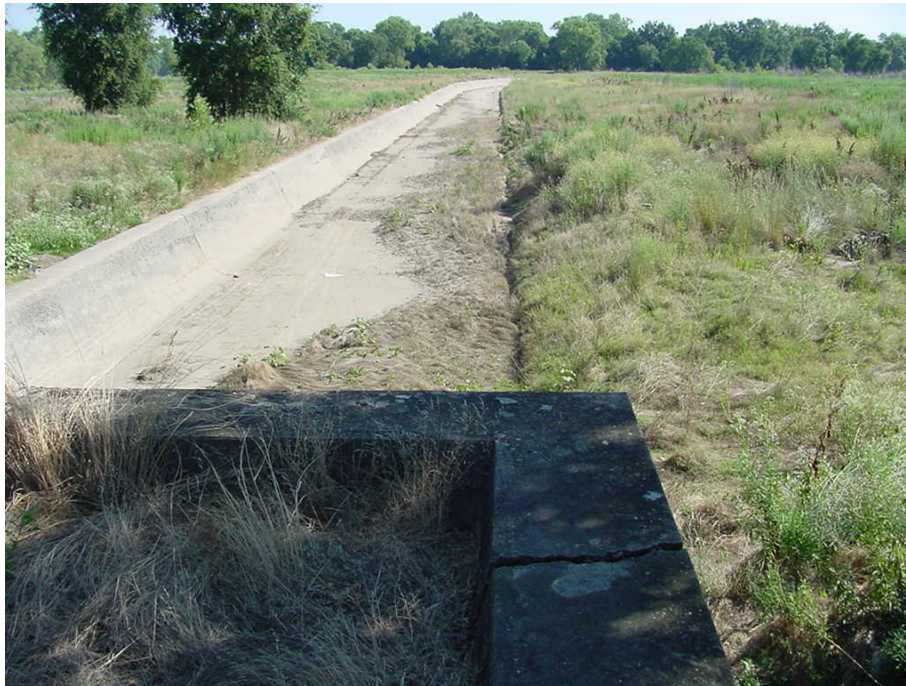
1. **Condition of concrete weir and stilling basin.**
 - a. **Some cracks and spalling exist on the weir and in the stilling basin as previously reported.**

- c. **North abutment has large cracks on east side.**
3. **Condition of revetment.**
 - a. **Good.**
4. **Accumulation of trash and debris around the structure or in the channel.**

View of the weir and stilling basin from the north abutment.
Note the crack in the abutment wall.

- a. **Good.**
7. **Comments:**
 - a. **Monitor the cracks and spalling and repair as needed.**
 - b. **Remove debris from the stilling basin prior to flood season.**

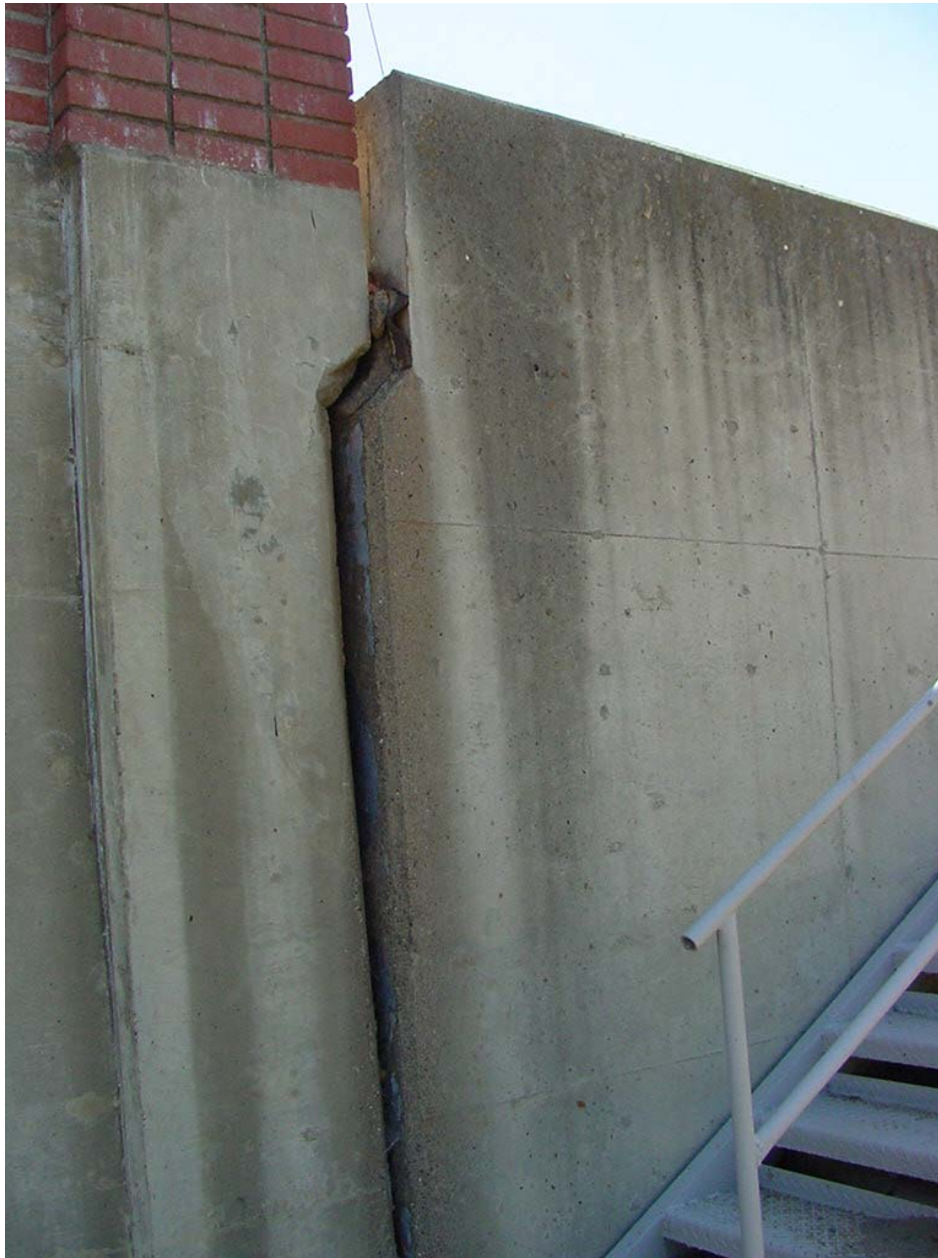
Three and five eighth inch deflection in the west retaining wall.

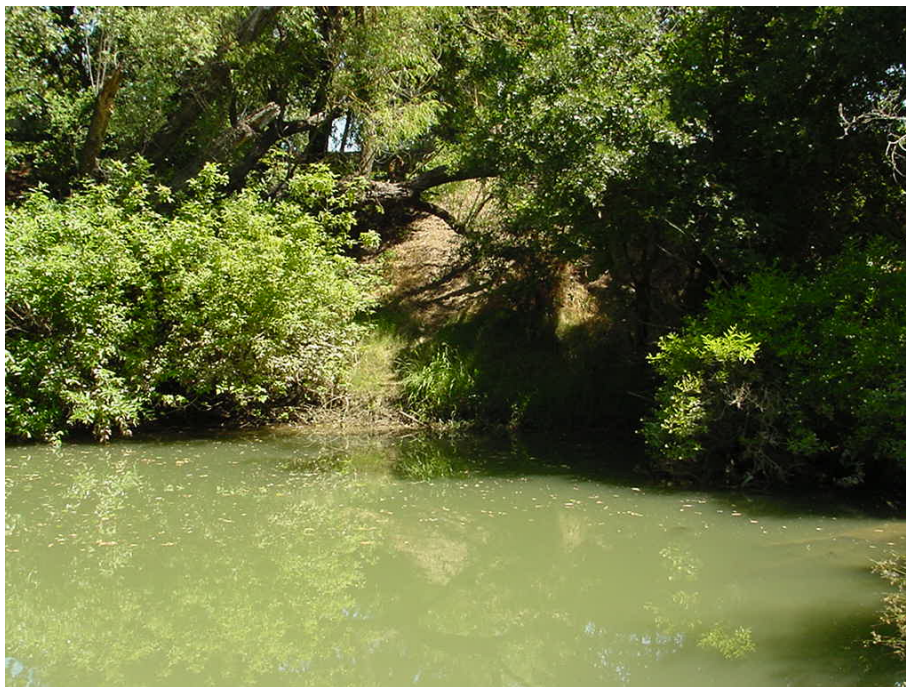
**View of the discharge side into Elk Slough.
The structure is under water.**

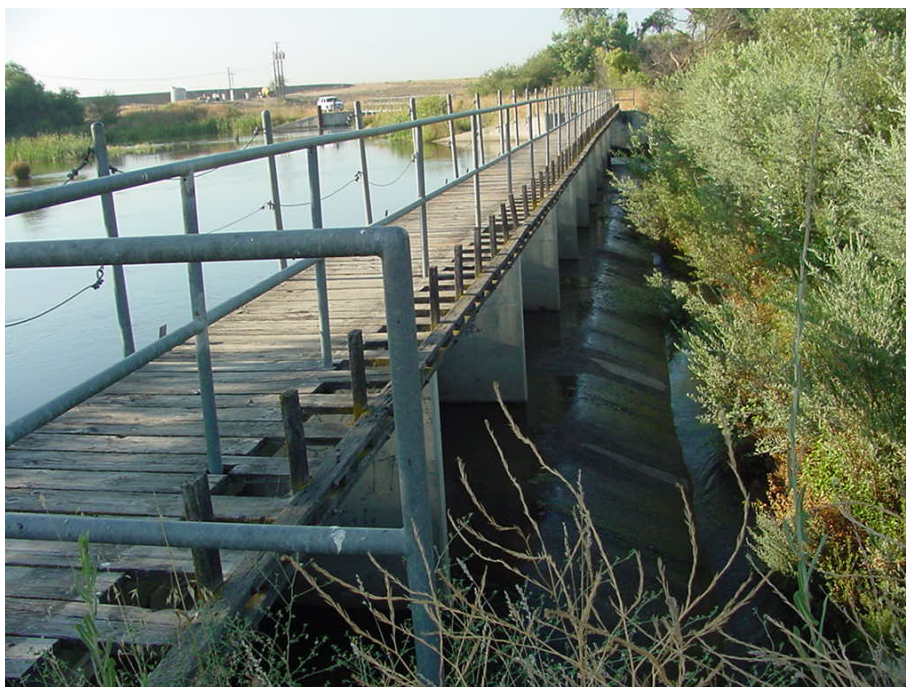
**The downstream side of the Ash structure.
Note the dense vegetation.**

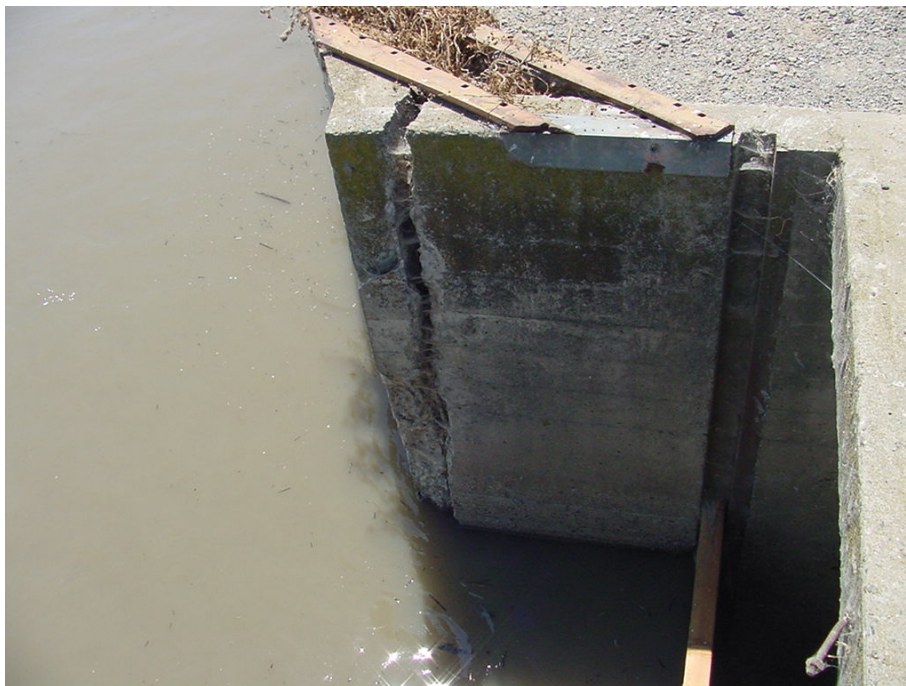
The 2 inch crack in the left bank abutment on the upstream side has been temporarily repaired.

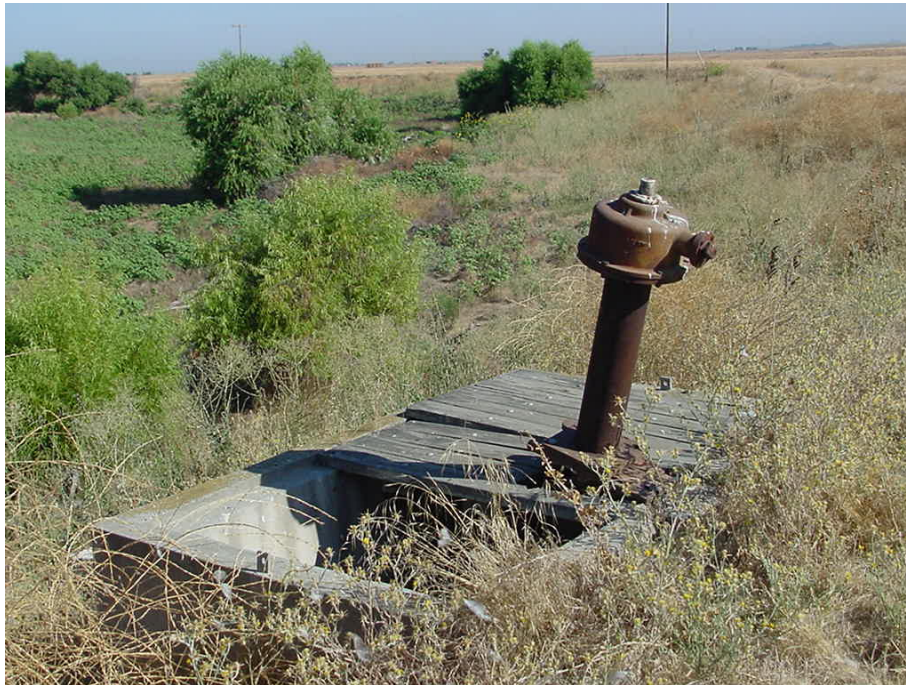
The damaged control gate mechanism.

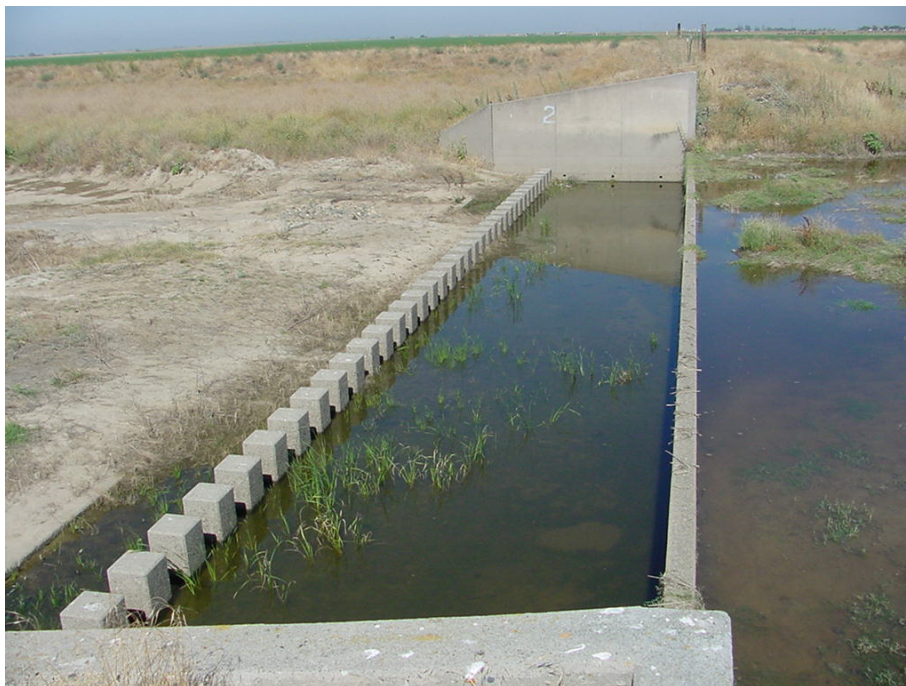
**The downstream side of the structure.
Sand is accumulating in the stilling basin.**

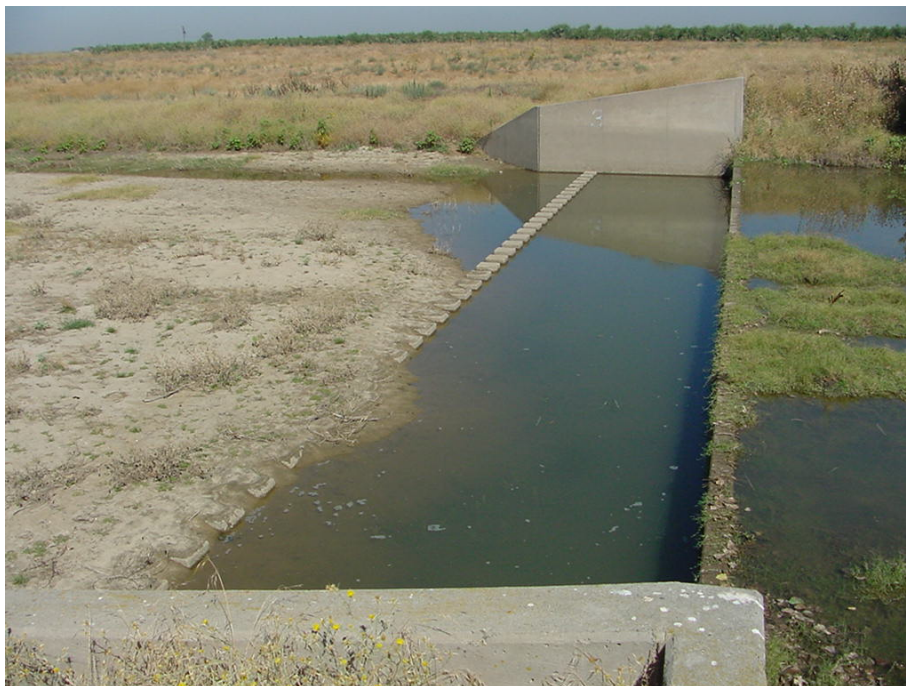
**The partially sand filled stilling basin.
The velocity dissipaters are covered by sand.**

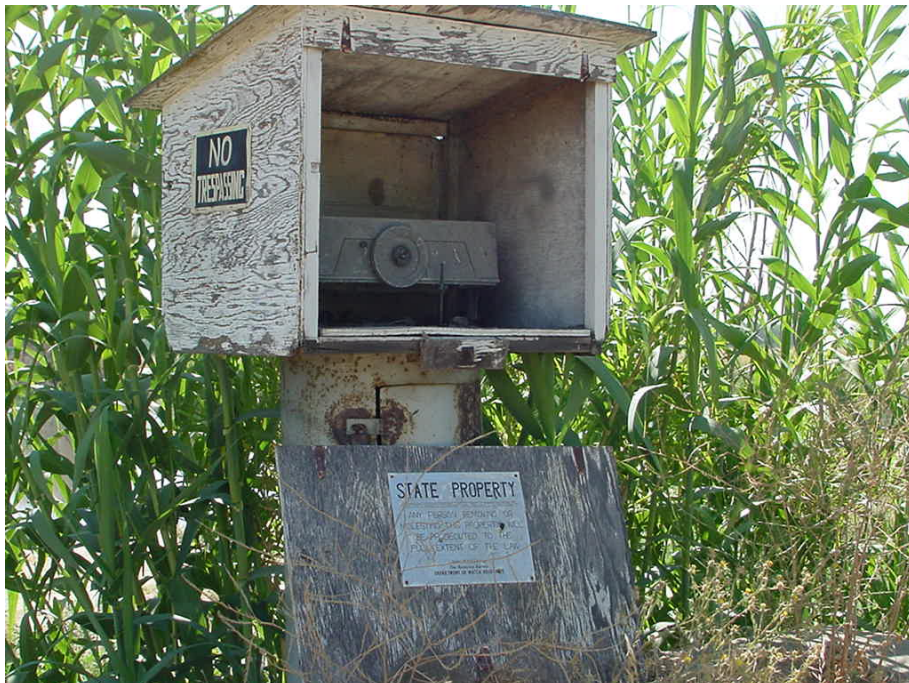
View of the non-functional gauging house and equipment.
